Manhole Inspection Summary

Manhole # S21E1_024MH

Insp Date: **5/22/08 11:34 AM**

Location Address: **2653 ridgely-huron alley**

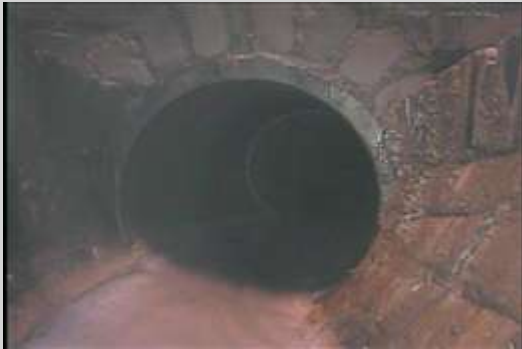
12 O'Clock Outflow

15 in. Circular Gravity Sewer
Pipe Out @ 12 O'Clock

Pipe Height: **15.6** (in.) Rod and Bar (Angled)
Pipe Material: **Clay** ☐ Pipe Lined
Invert Depth: **13.05** (ft.) Flow Characteristics: **Slow**
Deposits: ☒ None ☐ Mud ☐ Sludge ☐ Debris ☐ Grease
Silt Depth: **0** (in.) Deposits Extent:
Infiltration: **None** Pipe Seal Cond: **Sound**

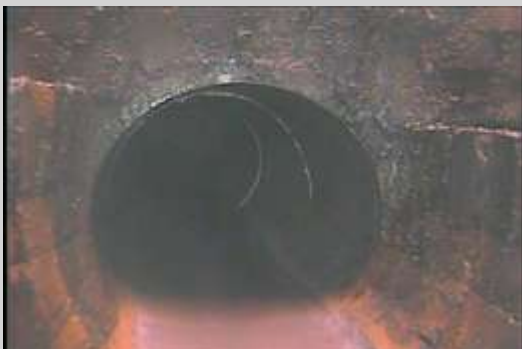
5 O'Clock Inflow

15 in. Circular Gravity Sewer
Pipe In @ 5 O'Clock

Pipe Height: **15.6** (in.) Rod and Bar (Angled)
Pipe Material: **Clay** ☐ Pipe Lined
Invert Depth: **12.69** (ft.) Flow Characteristics: **Slow**
Deposits: ☒ None ☐ Mud ☐ Sludge ☐ Debris ☐ Grease
Silt Depth: **0** (in.) Deposits Extent:
Infiltration: **None** Pipe Seal Cond: **Sound**
